# **Boston Alternative Energy Facility – Preliminary Environmental Information Report**

Appendix 11.1 Land Quality Phase 1 Preliminary Risk  
Assessment

Reference: PB6934-RHD-01-ZZ-RP-N-2011\_A11.1

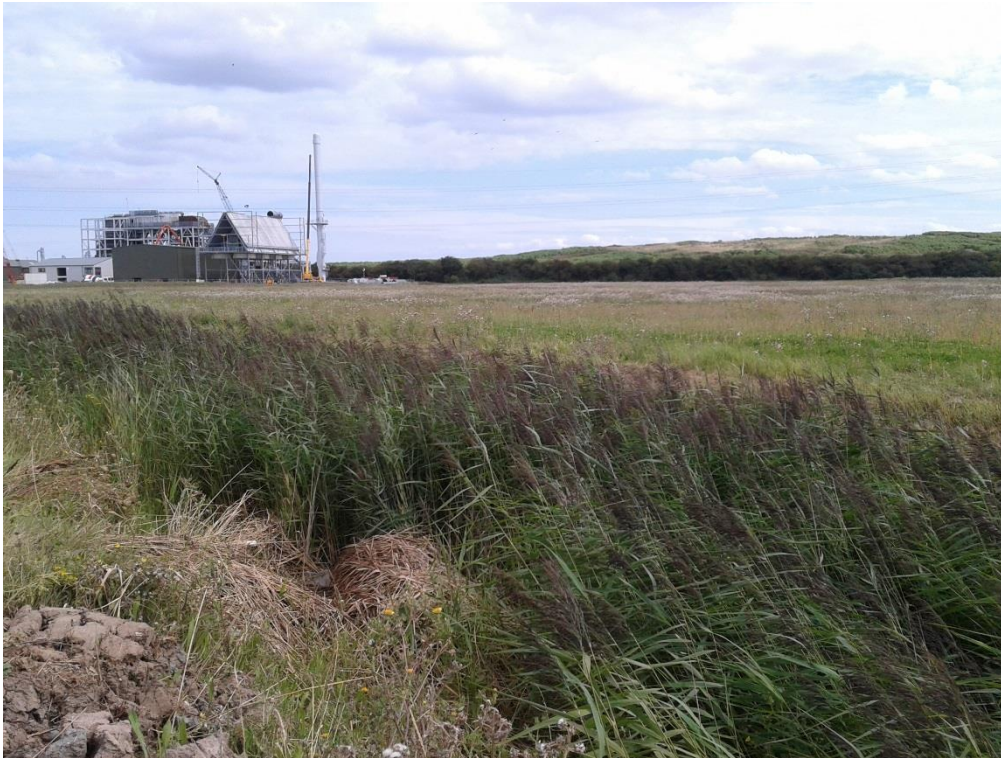
A11.2.4 The site is not fenced off and can be accessed from Bittern Way to the south and Nursery Road to the north. There is an internal track which crosses the site and connects Bittern Way and Nursery Road. The site topography is flat. Both areas appear to comprise semi-improved grassland.

**Plate A11.1.1.1 Boston 2 and 3 comprises mostly grassland**

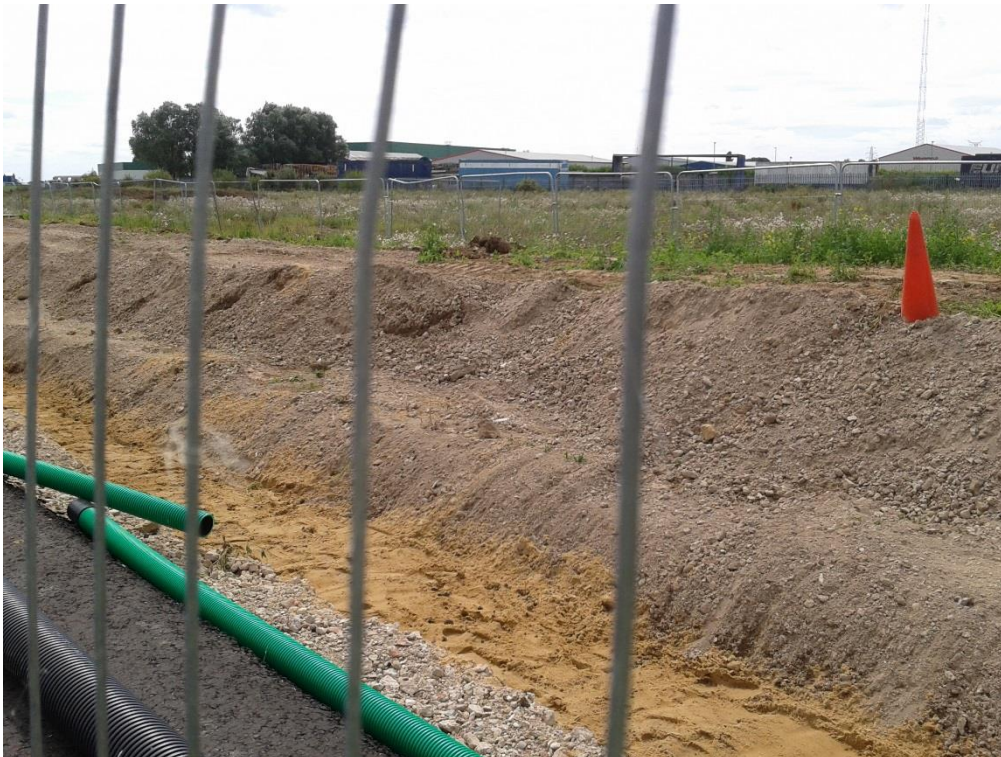
A11.2.5 There are no buildings or other structures on the site. There are open drainage channels crossing the site. The drains are densely vegetated (mostly by common reed). A new culvert is currently being installed along an existing track within Boston 2 by the local Council. An overhead electricity transmission line runs above the eastern boundary of the Boston 2 site.

**Plate A11.1.1.2 A Culvert is Currently being Installed along the Track in Boston 2**

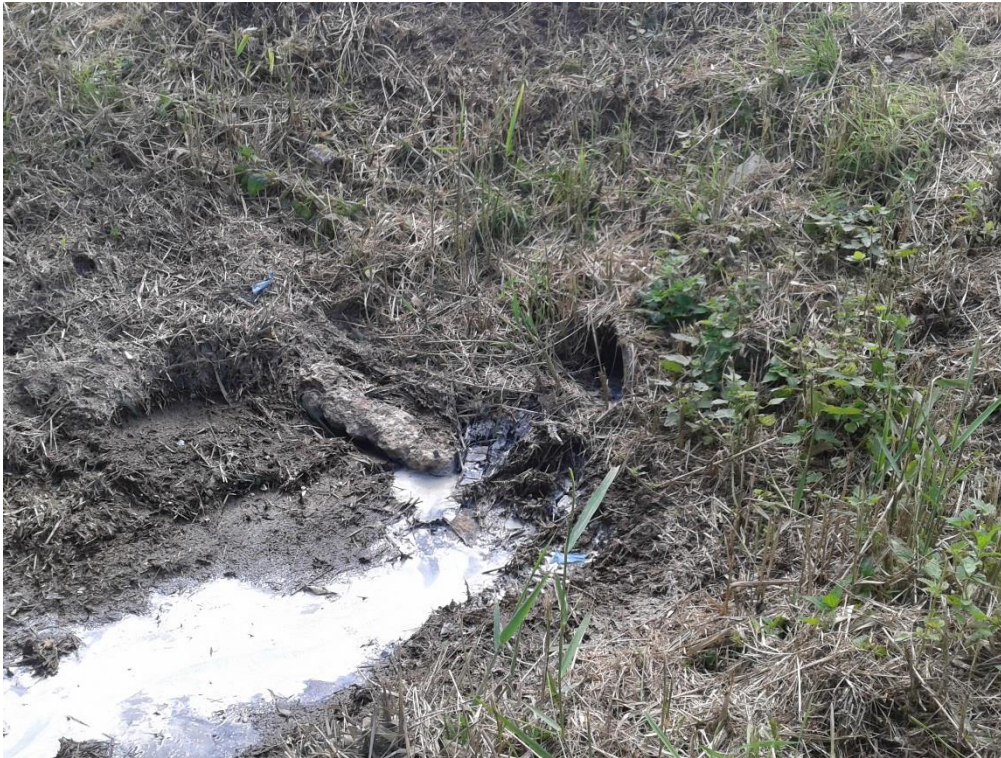
A11.2.8 A wide deep drain runs parallel to the embankment on its western side. The water levels were very low at the time of the survey. A partially collapsed culvert outfall was noted on-site. It is anticipated that there is culvert which runs along the

access track from Nursery Road and joins with the channel along the embankment. Several manholes were noted along the track.

**Plate A11.1.1.3 A Partially Collapsed Culver Outfall in Boston 4**

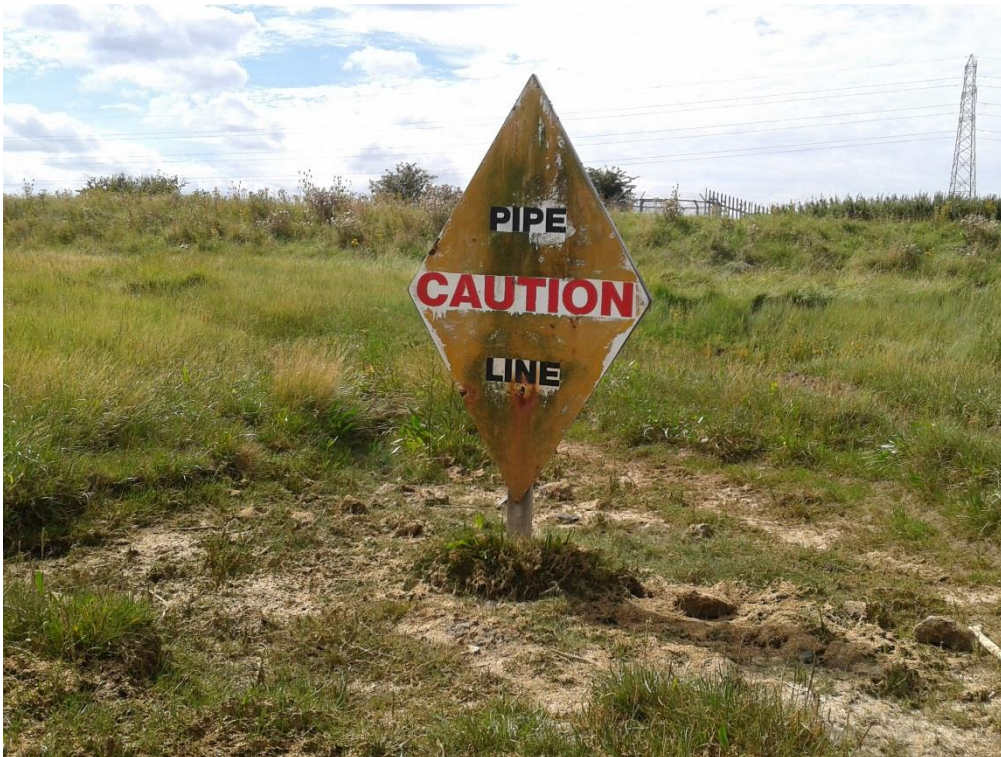
A11.2.9 A public footpath runs along the top of the embankment. A sign marking the position of an underground water main was noted during the survey on the waters-edge of the embankment.

**Plate A11.1.1.4 A Sign Marking Location of a Pipe Line**

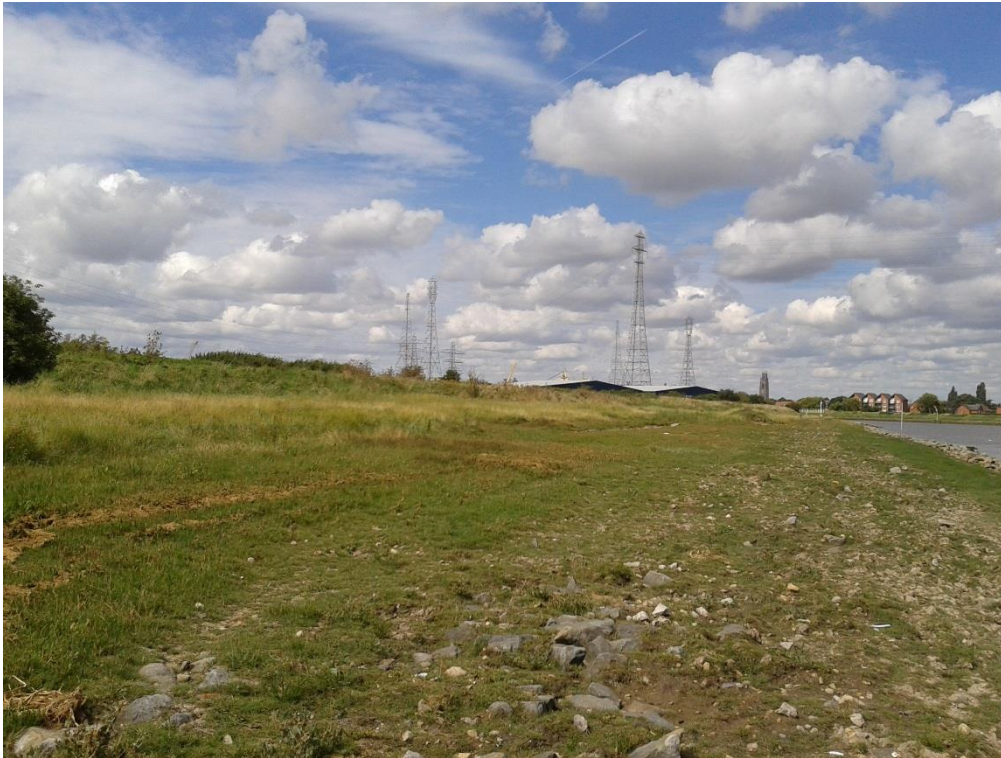
A11.2.7 The perimeter of the area is fenced with landside access via a gate on Nursery Road; or on the riverside via a gate on Lealand Way. The site is generally flat with a high embankment with steep slopes to the eastern edge, which runs along the Haven. A barbed wire fence runs along the embankment's toe. There is a track which runs along the dry side of the embankment and connects to the track coming from the Nursery Road.

**Plate A11.1.1.5 The Embankment along The Haven**

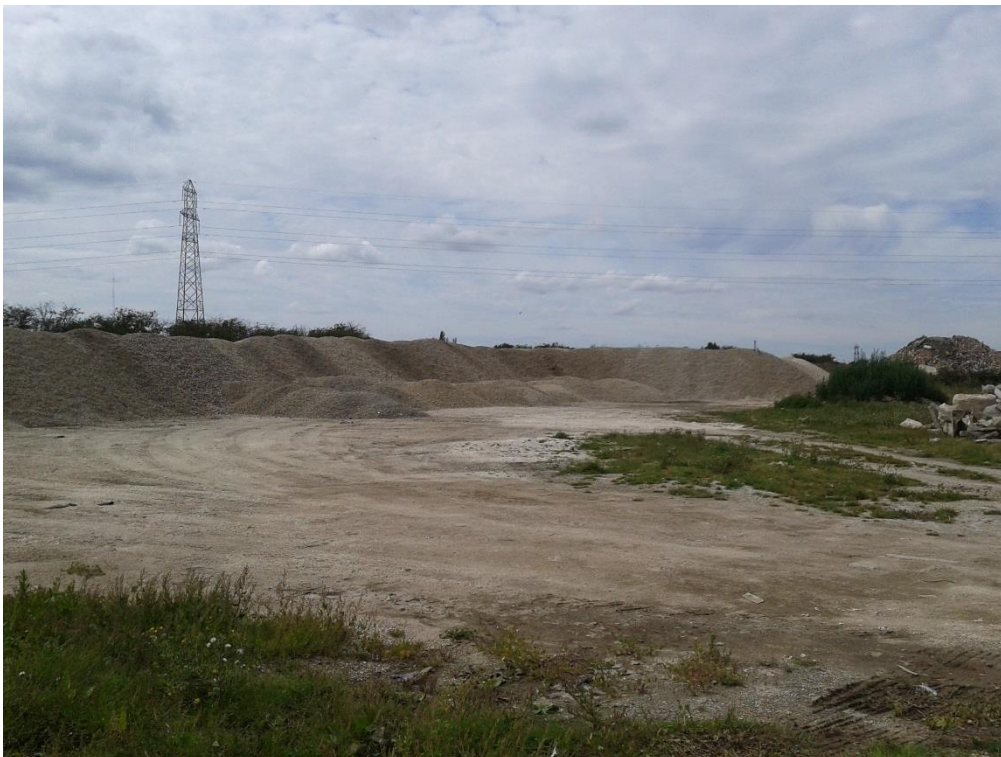
A11.2.12 The site is currently used for storing sands and gravels and some construction type waste (mostly reinforced concrete). A metal container was noted on site. No invasive species were noted on site.

**Plate A11.1.1.6 Sand and Gravels stored in Boston 5**
